Asset Inventory Template

15 May 2023 / JK Harrington

Score	0%	Flagged items	0	Actions	2
Company Name	HHJ Corporation				
Created on	15.05.2023 17:30 PST				
Prepared by	JK Harrington				
Location	Michigan, USA (44.3148443, -85.60236429999999)

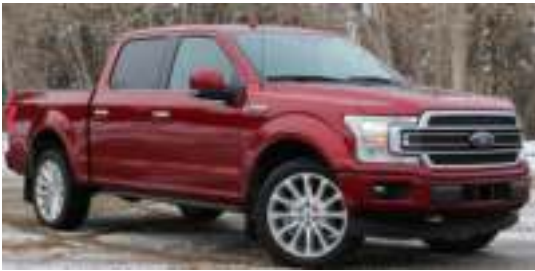
Photo 1

2019 Ford F-150

In Good Condition/In Use

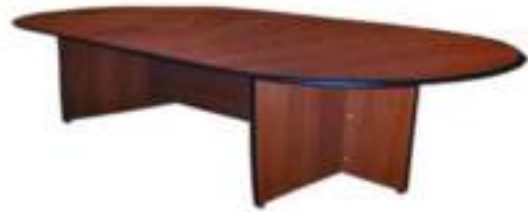
Photo 2

Conference Table

In Good Condition/In Use

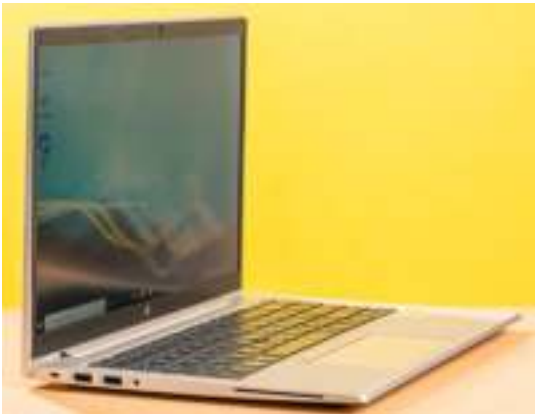
Photo 3

Asset Name	HP EliteBook Laptop
Asset Description	14-inch laptop with Intel Core i7 processor, 8GB RAM, and 256GB SSD
Asset Group	Equipment
Unique Identifier/Tag and Location	EL-006-EL016, Desks 6-15
Asset Quantity	10
Asset Cost/Value	\$1,200 each
Investment Time	January 2022
Status and Condition	In Good Condition/In Use
Maintenance Schedule	Every 6 months
Supplier Name, Address, and Contact Details	HP Inc., 1501 Page Mill Road, Palo Alto, CA 94304
Shipping/Delivery Time	3 business days
Estimated Shipping Costs	\$100 per laptop
Reorder Policies	When the quantity falls below 5 units
Asset Details and Audit 4	2 actions

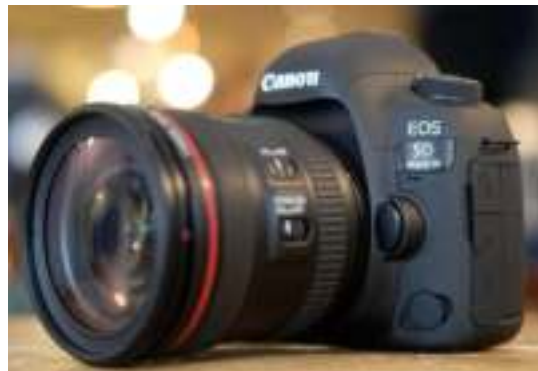
Photo 4

Needs Repair or Replacement/Under Maintenance

Both cameras were used last week for the shooting of our Onboarding video and Company promotional video (see the attached incident report). They weren't properly packed and returned to the studio which resulted in them being damaged in transit. Only minor defects were found, and the repair action is already created in this item for assigning and resolution before this week ends.

Repair 2 DSLR cameras.

Order 2 Canon DSLR units that will serve as our backup cameras.

It is recommended to have the cameras repaired as soon as possible to avoid delays in projects that require high-quality photos or videos. It's also recommended to have backup cameras available in case of equipment failure.
