Bridge Inspection Checklist

Document No. 005628

Amaranth Corp Redux

008-4/5-2.95(01214)

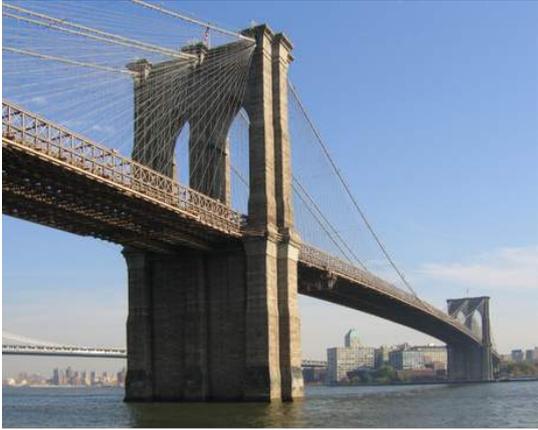
Photo 1 - Upstream Face

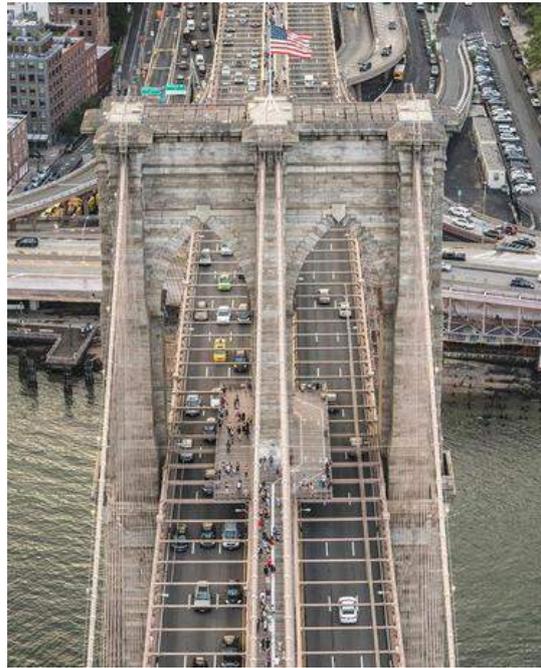
Photo 2 - Downstream Face

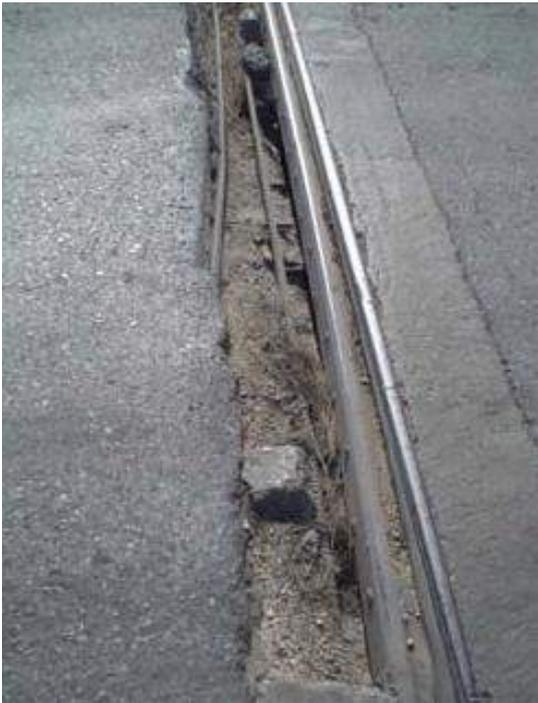
Photo 3

Joint Condition

Poor

Check and apply silicone seal for reinforcement.

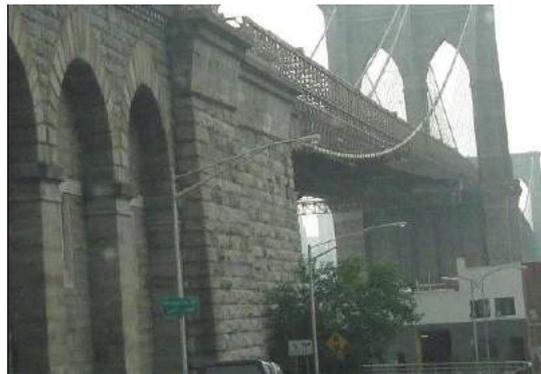
Photo 4

Back Wall

Fair

No noticeable damage.
