Chimney Inspection Checklist

AH-215594 / 20 Jun 2023

Score	90%	Flagged items	2	Actions	1
Site conducted					Unanswered
Service Number					AH-215594
Customer					Kevie Roms
Location				Estate Enighed, Independence, KS 67301, USA	
Conducted on (Date and Time)					20.06.2023 15:34 PST
Prepared by (Full Name)					Joe Lengco

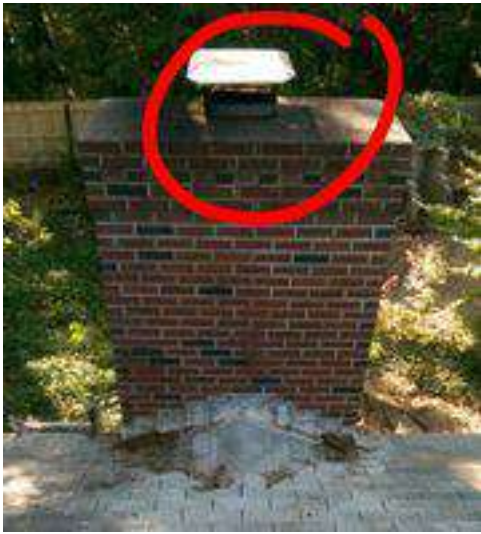
Photo 1

Loose chimney cap

Fix loose chimney cap

The chimney cap is loose - It needs to be fixed
Chimney flashing needs repair and the chimney requires creosote cleaning.

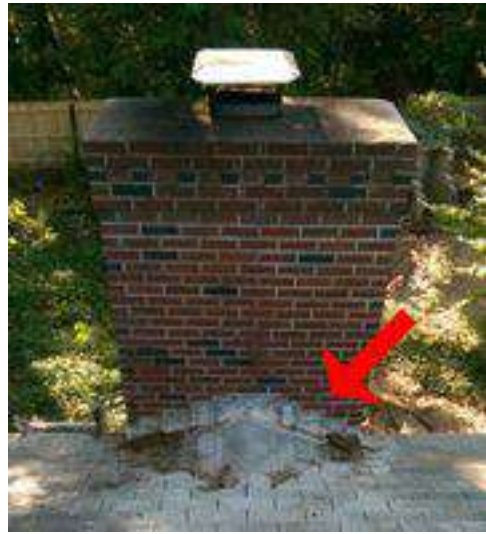
Photo 2

Damaged flashing this needs repair

Brickwork / Mortar	Satisfactory
Flashing	Unsatisfactory
Damaged flashing this needs repair
