General Construction Risk Assessment Template

Boards and Nails Corporation / Mateo Roman / 4
May 2023

Construction Risk Assessment

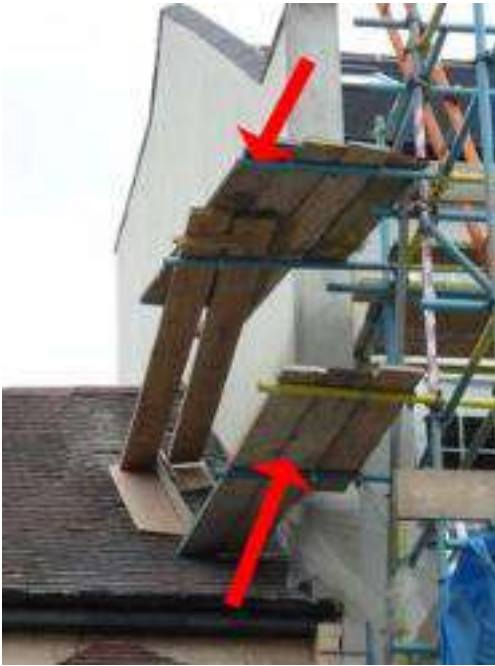
Photo 1

Working at Heights

Looked like a makeshift scaffold - but overall dangerous. Planks must be secured and tied to beams and braces.

High

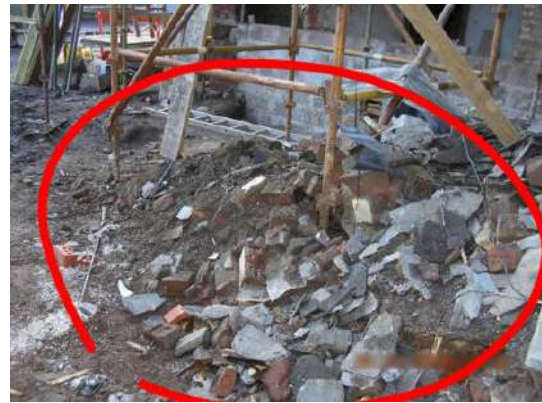
Photo 2

Walkways

Poor housekeeping - debris, dust/ trash should be cleared off the walkways to avoid obstruction.

Medium

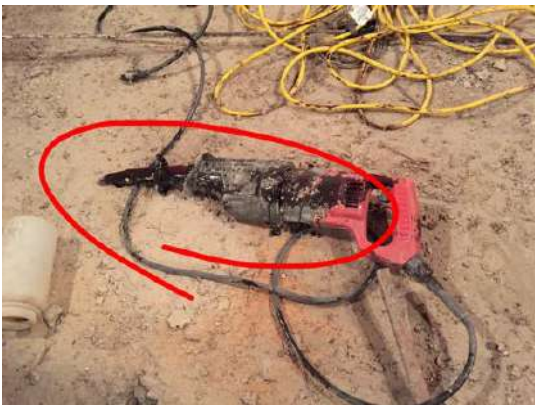
Photo 3

Power Operated Tools & Equipment

Damaged equipment such as this should be kept in a proper storage area and must be replaced as soon as possible to avoid any injuries or further risks.

High

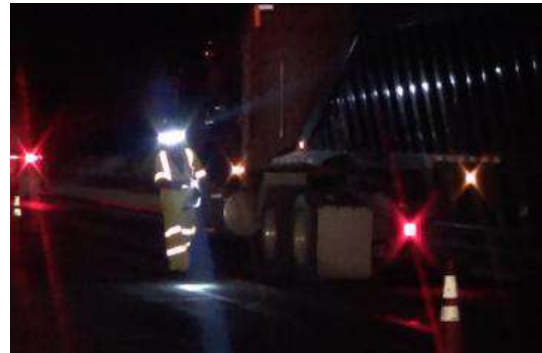
Photo 4

General Work Environment

Inadequate lighting in work areas. Terrible.

High

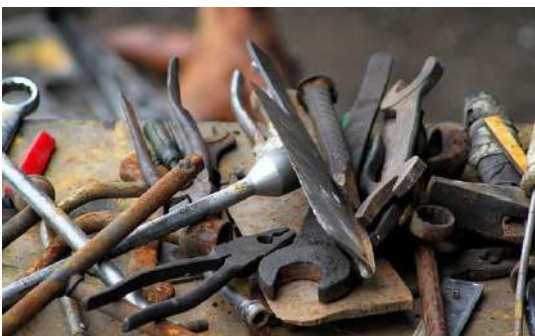
Photo 5

Hand Tools & Equipment

This is just too messy. Tools must be grouped properly. Some are rusty and not healthy for use. This should not be exposed and must be properly stored in a container/ handheld toolbox.

Medium

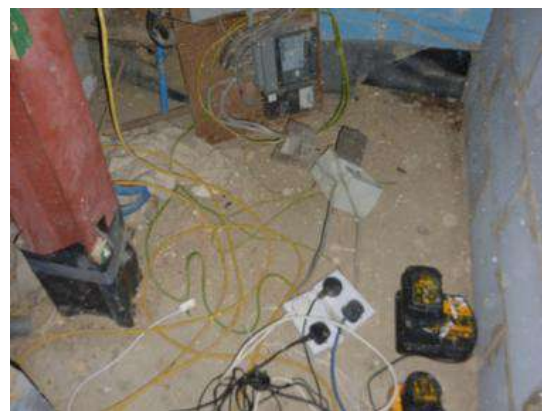
Photo 6

Electrical

Messy wiring and is a trip hazard. Please fix this within the day or ASAP

Medium
