Leak Inspection Checklist

Francis and Co. Inc. / 31 May 2023 / Carl Shee Escan

Water leakage near the office parking area

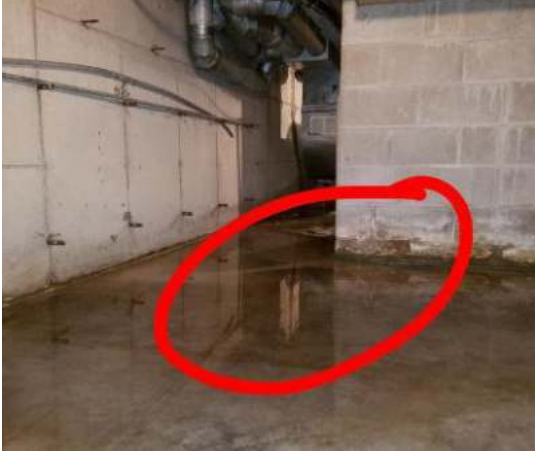
Photo 1

No evidence of standing water

There is an evident standing water about 10 cm deep.

Secure the area

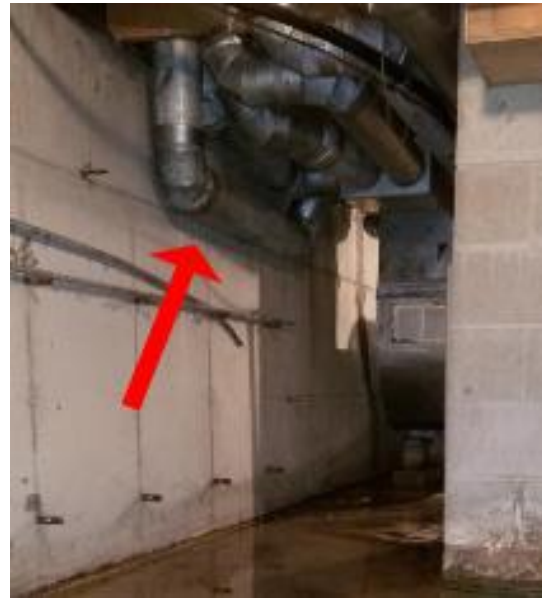
Photo 2

level 2 parking lot bay 3

Broken seals

Pipe replacement (use nominal bore 16 inch (DN 400mm), outside diameter 406.4mm)
