Pressure Vessel Inspection Checklist (Unfired)

28 Jun 2023 / Bernard F

Score	89.47%	Flagged items	4	Actions	0
Conducted on	28.06.2023 10:03 PST				
Prepared by	Bernard F				
Location	San Jose, CA 95135 United States (37.3084816473777, -121.6406824504114

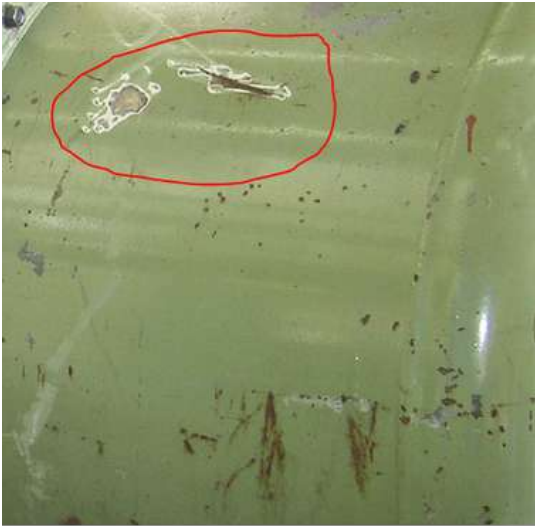
Photo 1

Visible dent observed. Urgent need of repair.

Found cut. Initial assessment is for repair only but will determine if need to be replaced after test.

Free of cuts or gouges?

No

Determine if should be repaired or replaced

Found a cut and a dent. Will conduct test to determine if can be salvaged by repair or needs replacement. If can still be repaired, will proceed with reapplication of corrosion resistant coating on vessel and piping.

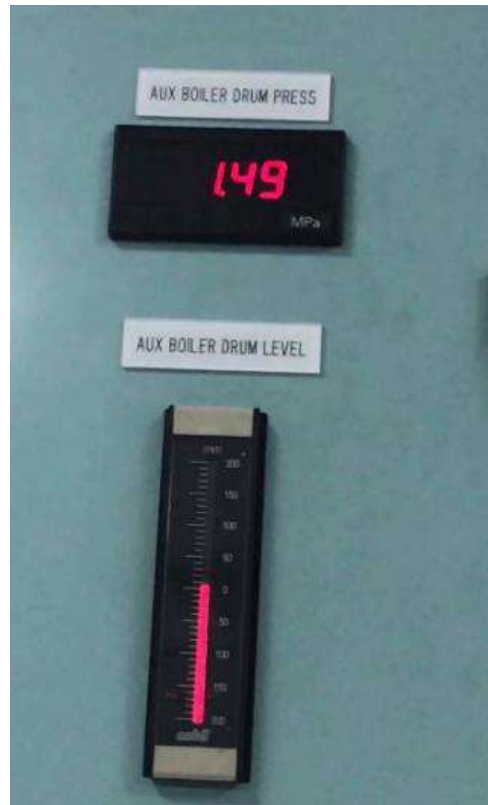
Photo 2

IMPORTANT: The set pressure is not higher than the maximum allowable working pressure (MAWP) marked on the pressure retaining item?

Yes

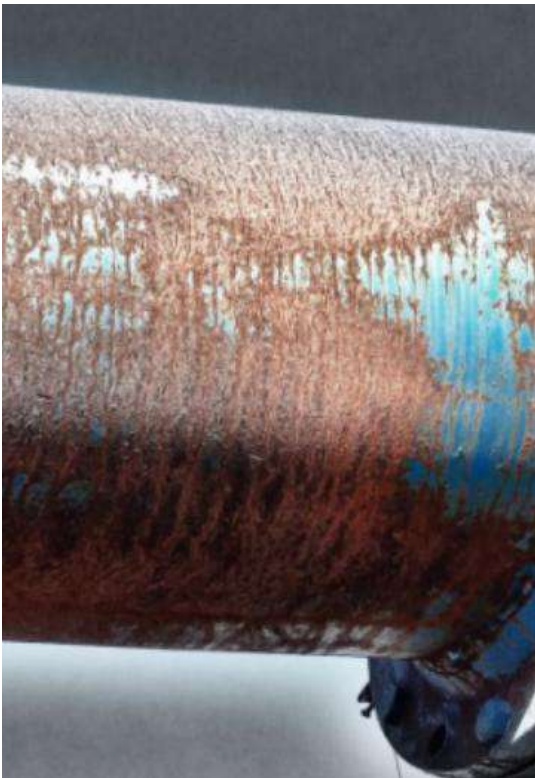
Photo 3

No evidence of corrosion, erosion, or cracking or other detrimental conditions?

No
