# Racking Inspection Checklist

5 May 2023 / Blanche Monforte / SVC Warehouse

3485 Broadway Avenue,  
Chattanooga, Tennessee 37415

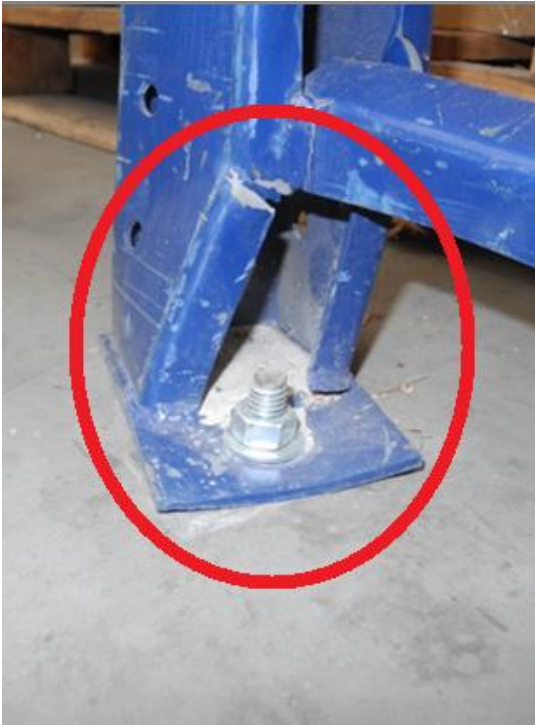
Photo 1

Rear base plate

Amber risk (significant damage)

13mm twisted base plate, no shims installed

Off-load, repair and install

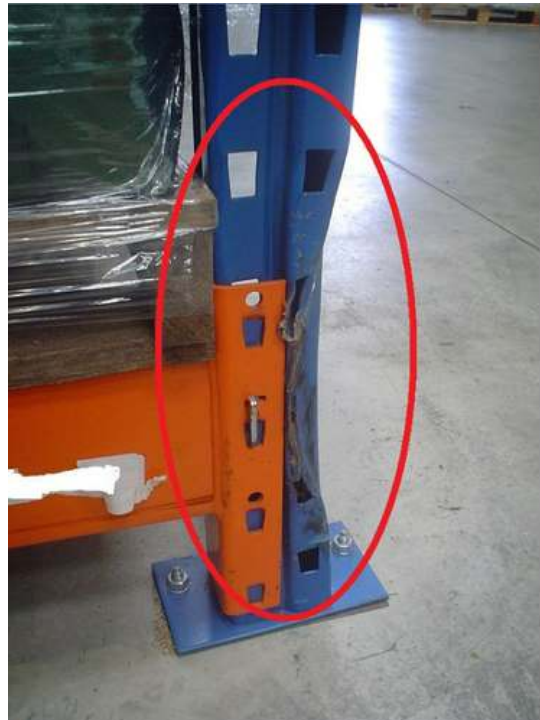
Photo 2

Front uprights

Red risk (critical damage)

Side impact is over 10mm, no front upright guard installed

Off-load NOW, replace and install

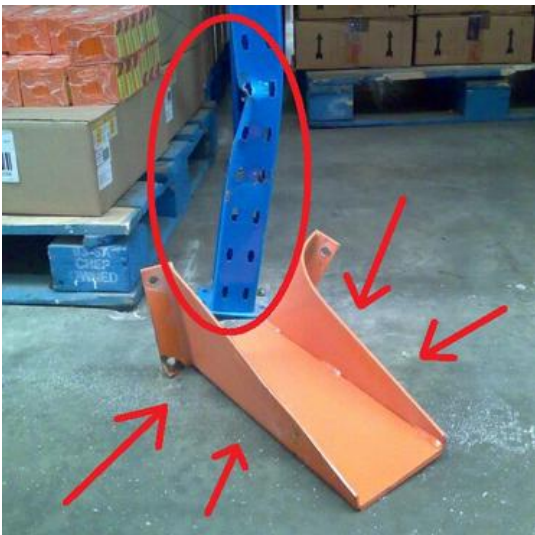
Photo 3

Front uprights

Front shims

Upright Guards

Red risk (critical damage)

The detached rear upright guard and missing anchor bolts are also a slip, trip, and fall hazards!

Off-load, remove and locate NOW

Isolate, replace and install

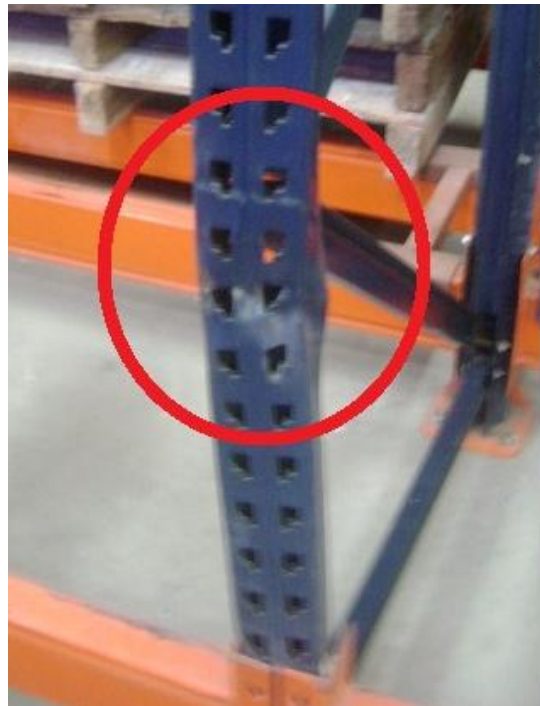
Photo 4

Rear uprights

Amber risk (significant damage)

8mm side impact to rear upright

Off-load and repair
