# Roof Inspection Checklist

Mr. Seonil Jung / Potts Point / 30 May 2023 / Riley Bautista

Score	<b>80.56%</b>	Flagged items	<b>8</b>	Actions	<b>0</b>
<b>Client / Site</b>	Mr. Seonil Jung / Potts Point				
<b>Conducted on (Date and Time)</b>	30.05.2023 08:52 PST				
<b>Inspected by</b>	Riley Bautista				
<b>Location</b>	57 Victoria St, Potts Point NSW 2011, Australia (-33.8692466, 151.223138)

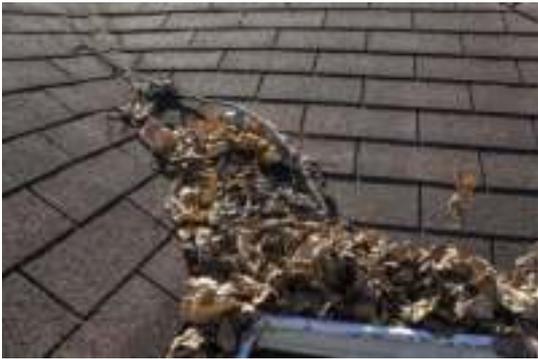
Photo 1

**Debris on Roof**

Leaves were found on one corner of the roof

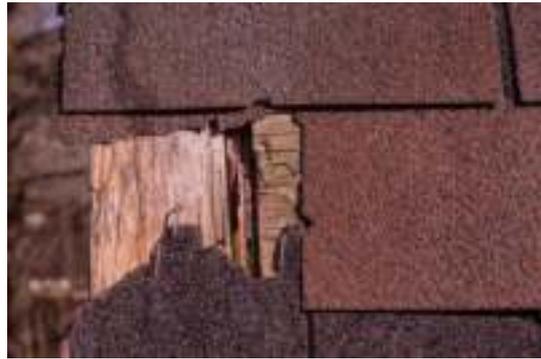
Photo 2

A cracked shingle was discovered on the left side of the house. It was probably caused by the recent storm in the area.

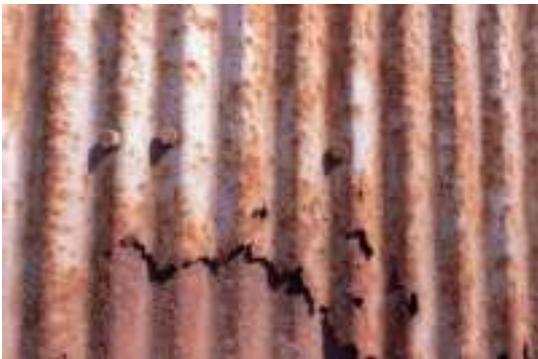
Photo 3

**Metal Corrosion**

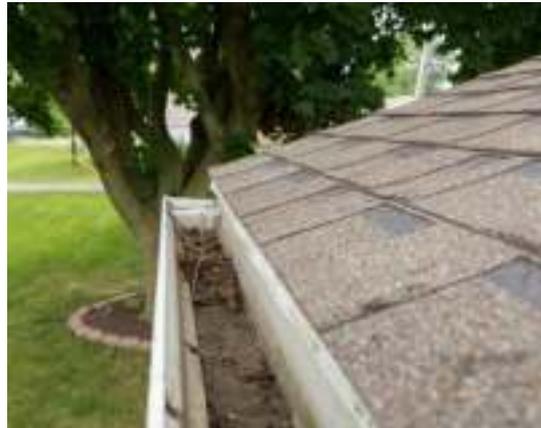
Photo 4

**Gutters / Drains, etc.**

Damaged

Gutter is clogged with tree leaves and sticks

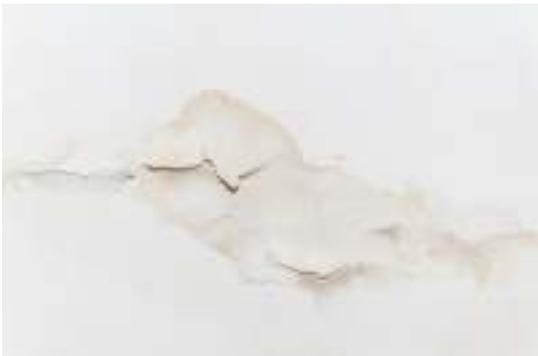
Photo 5

#### Cracks

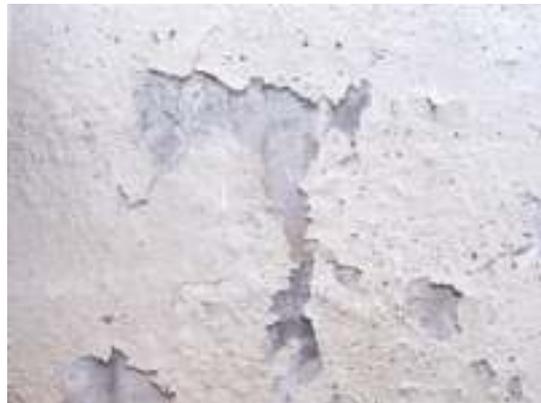
Photo 6

**Deformed Finish**

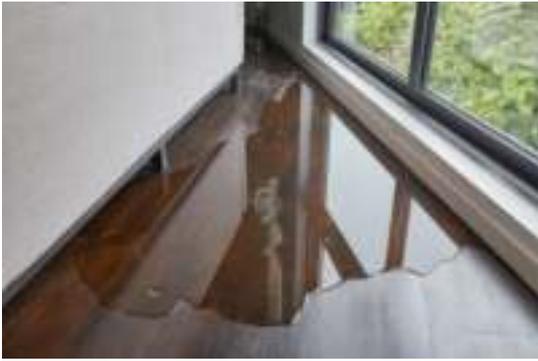
Photo 7

### Window Leaks

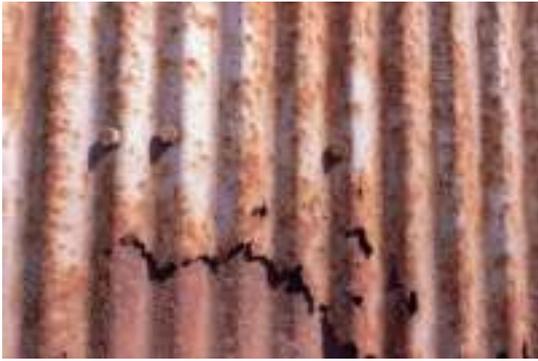
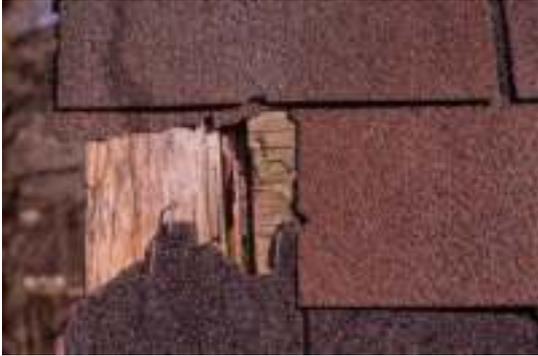
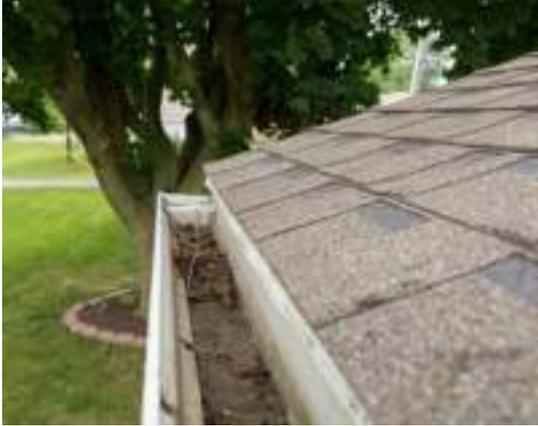
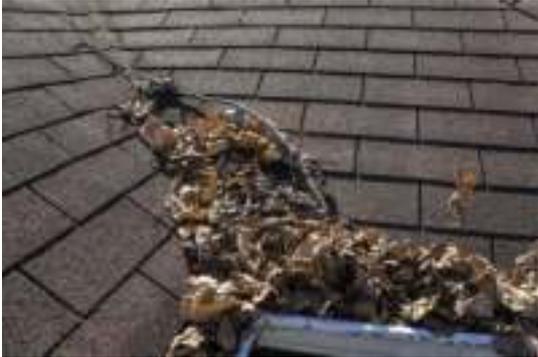
There were some minor findings seen on the roof, mainly due to the current season and the recent storm that came. These were already raised to the property owner and the proper remedial actions have already been identified.
