# Construction Risk Assessment Form

21 Feb 2023 / 372-2345 / Jeremiah Ronson

Construction of 2-story building as new retailer complex.

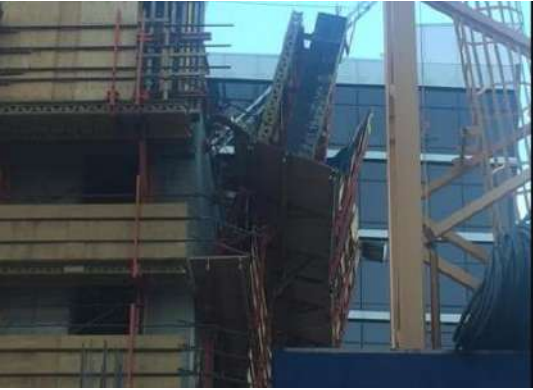
Photo 1

Loose scaffolding on the west side of the building. Foreman was immediately informed. This problem should be fixed before the end of the day. Prohibit workers from working on or underneath loose scaffolding.

Injury and/or fatality by being struck by objects or through possible falls are imminent unless scaffolding issues are fixed ASAP. Action already created.

Fatality/ Disability

High

Standards, materials, and practices concerning scaffolding, working at heights, and falling objects must be reviewed. Loose scaffolding was detected in the west side of the building which had the potential to cause major injuries and fatalities.

All workers and personnel were cleared from the immediate vicinity of the loose scaffolding. A "restricted area" was established with barriers and tapes to ensure that no one would be in danger of falling objects from the loose scaffolding detected.
