G 90 Transformer Maintenance

22 Jun 2023 / Iovianus Elwira

Audit	2 flagged, 1 action, 91.67%
Turbine Number	102
Start Time	22 Jun 2023 09:00 PST
Stop Time	22 Jun 2023 10:00 PST

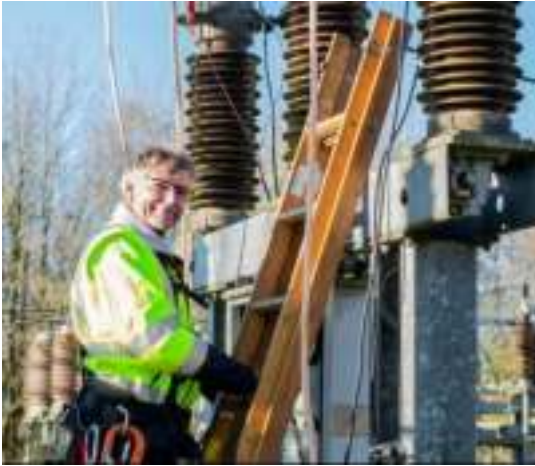
Photo 1

8.18.2 VISUAL INSPECTION OF THE TRANSFORMER'S FASTENERS

Currently under repair.

8.18.1 VISUAL INSPECTION OF THE TRANSFORMER NEUTRAL CABLE (LOW VOLTAGE SIDE)	Pass
8.18.2 VISUAL INSPECTION OF THE TRANSFORMER'S FASTENERS	Fail
