# Vehicle Inspection Checklist

Robbie White / Jason Reyes / 21 Jun 2023

Ford Everest 2015 Dark Blue

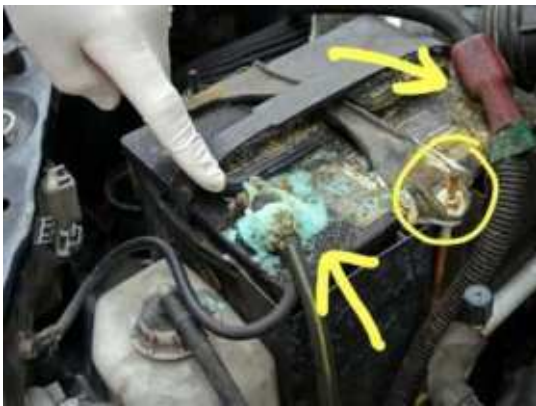
Photo 3

<b>Fan/compressor belts</b>	OK
<b>Oil pressure</b>	OK
<b>Radiator</b>	OK
<b>Battery</b>	Needs Repair

Car battery became more pronounced. Colder temperatures made the engine oil much thicker.

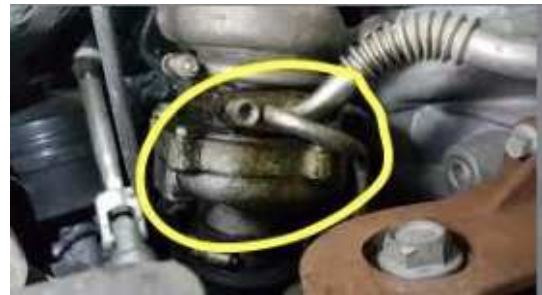
Photo 4

### Visible leak

Needs Repair

Leaks found on fuel engine system.

2. Check for leaks.
  3. Inspect tire pressures.
  4. Be mindful of the steering system.
  5. Clean the brake dust off of the wheels.
  6. Check oil levels.
-

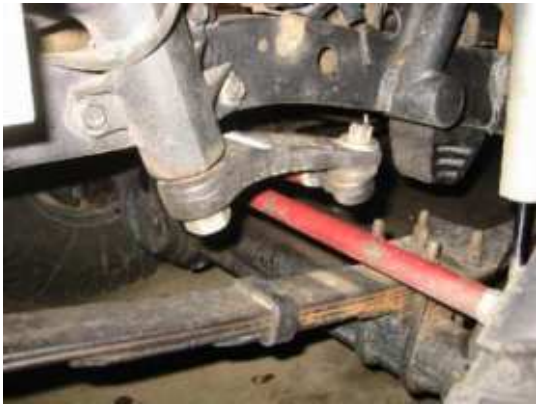
Photo 5

Steering wheel free play	OK
Steering column	OK
Front axle beam	OK
Steering gear box	OK
Pitman arm	Needs Repair

Noticed some steering problems due to poor condition of pitman arm.

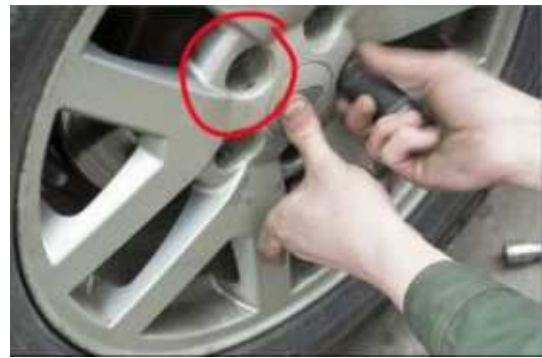
Photo 6

Wheels and rims	OK
Lock or side rings	Needs Repair

Side rings are dirty.
