Visual Inspection Report Form

1 Feb 2023 / Samantha Leibnitz / Welding

Steelix Manufacturing Ltd.

Welding

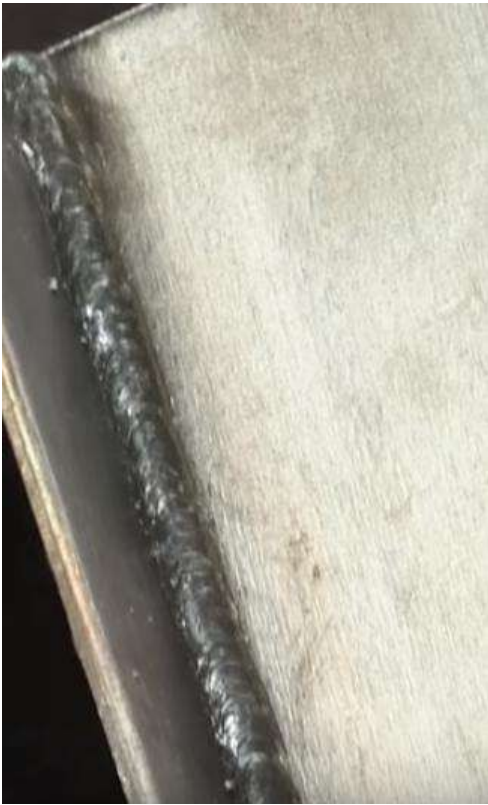
Photo 1

01 / AE03

Pass

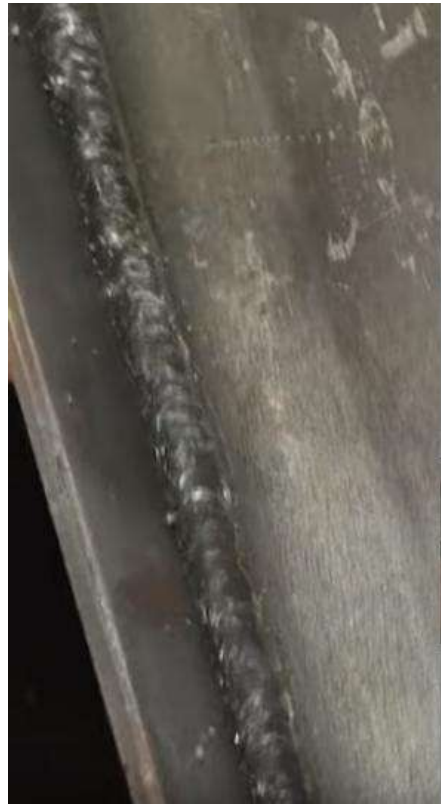
Photo 2

02 / AE03

Pass

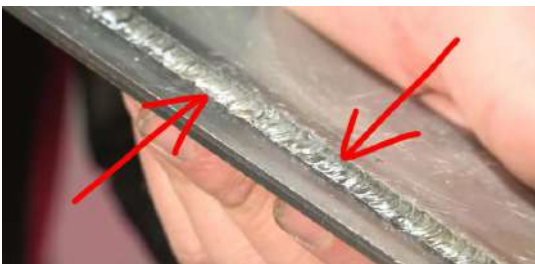
Photo 3

03 / AE03

Fail

Incomplete fusion

Arc strikes

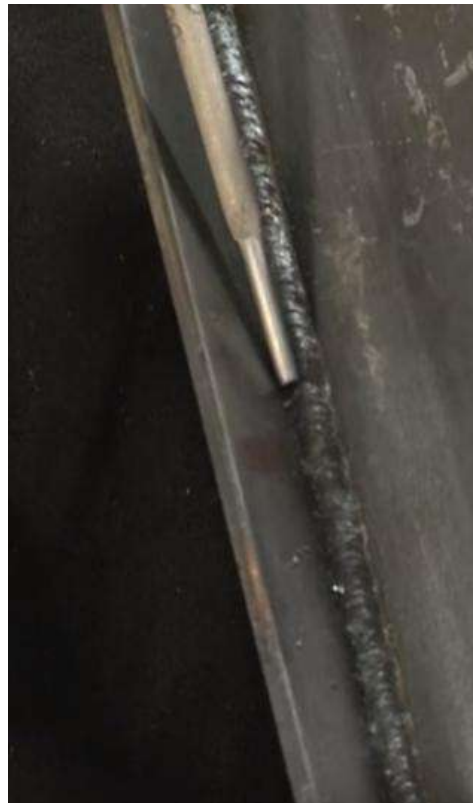
Photo 4

04 / AE03

Pass

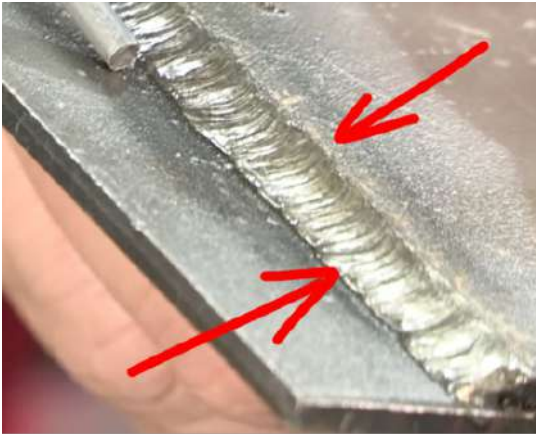
Photo 5

05 / AE03

Fail

Burn through

Under cut

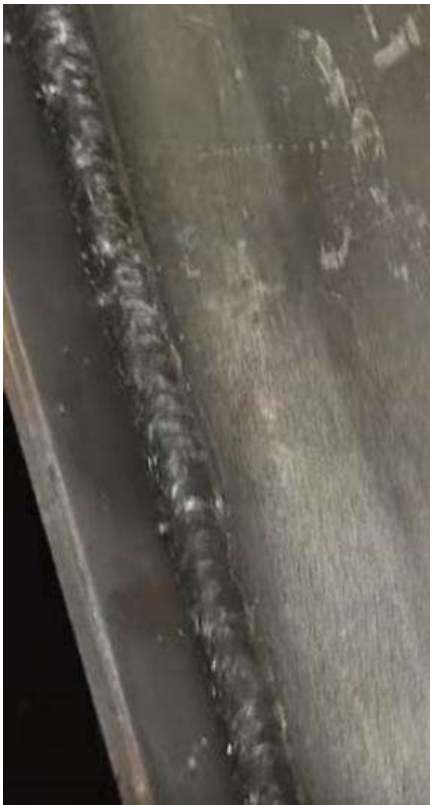
Photo 6

06 / AE03

Pass
