Fix and Waterproofing Inspection Checklist

30 May 2023 / Philip Dunphy / Fixing Stage /
Matthew Davis

Score	50%	Flagged items	3	Actions	3
Site conducted					Unanswered
Client Name					Philip Dunphy
Subject Property				14 Pine St, Marrickville NSW 2204, Australia (-33.9086828, 151.1456221)	
Builder					Maslow Corp
Inspection Date & Time					30.05.2023 07:55 PST
Inspected By					Matthew Davis
Stage of Work					Fixing Stage

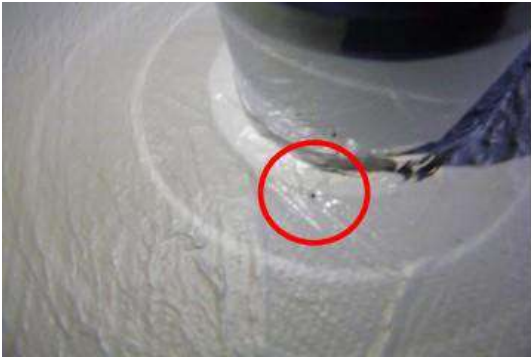
Photo 1

These are numerous holes in the waterproofing membranes applied to the wet areas of this home, which will likely lead to water leaks and damage in the future.

This waterproofing has been poorly applied with no care taken whatsoever, all of these areas will need to be rectified and properly waterproofed so the wet areas are actually waterproof

Rectify waterproofing holes in wet areas

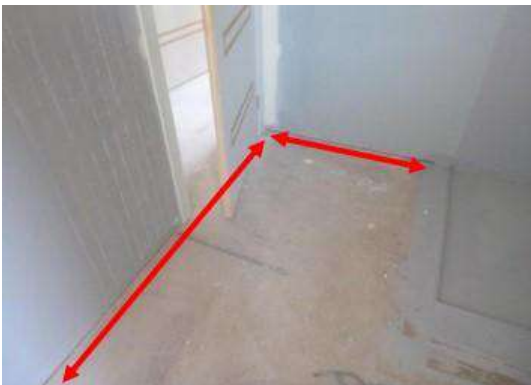
Photo 5

None of the wall/floor junctions or door openings throughout the wet area rooms of this home have been properly waterproofed as required by the BCA and the relevant Australian Standard - AS 3740, which will allow water to leak into the frame and cause possible future damage.

Notify the builder in charge to install waterproof wall/floor junctions to all of the wet areas of this home as required by the NCC/BCA and the relevant Australian Standard - AS 3740

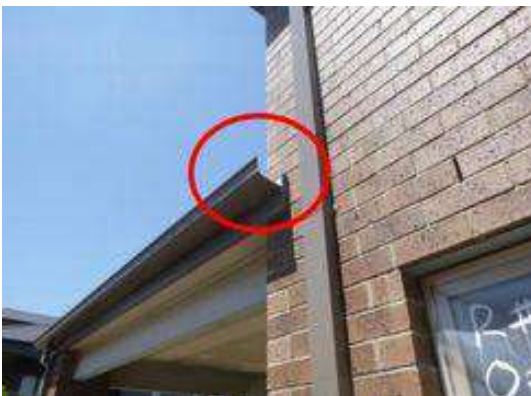
Photo 7

The downpipes have not been connected (temporary or otherwise) to the stormwater system throughout most of this build, which has directed water onto the ground adjacent to the footings and may be contributing to future slab heave issues. There have not been temporary downpipes fitted to the gutters of this house, which is directing water collected from the roof onto the ground immediately adjacent to the footings.

Notify builder to immediately place temporary downpipes fitted to the gutters, and the site drainage rectified to prevent further ponding of water against the footings
