Incident Report - First Response

Score	1 / 6 (16.67%)	Flagged items	0	Actions	1
Document No.					02812209-IR
Audit Title					Electrical Hazard Incident Report
Client / Site / Project					Electrical System Maintenance and Repair - 2nd floor, RDJ Commercial Spaces, Inc.
Report conducted on					22 Sep 2023 13:00 PST
Prepared by					Jake Cobb - Team Lead
Location					Los Angeles, CA, USA (34.0549076, -118.242643)

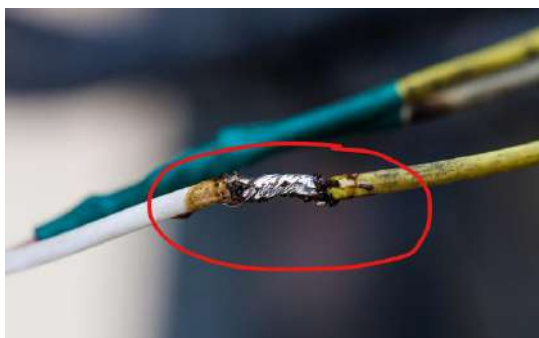
Photo 1

Audit	1 action, 1 / 6 (16.67%)		
First Incident Details	-2 / 3 (0%)		
Date & Time of Incident	22 Sep 2023 12:30 PST		
Location of Incident	Los Angeles, CA, USA (34.0549076, -118.242643)		
Incident Priority?	High		
Site / Project Name	Electrical System Maintenance and Repair - 2nd floor, RDJ Commercial Spaces, Inc.		
Incident Type?	<table border="1"> <tr> <td>Hazard</td> <td>Injury</td> </tr> </table>	Hazard	Injury
Hazard	Injury		
Name of on-duty supervisor at time of incident?	Hailey Park		
Is immediate medical attention required?	Yes		
What kind of medical attention was administered?	<table border="1"> <tr> <td>First Aid</td> <td>Hospital</td> </tr> </table>	First Aid	Hospital
First Aid	Hospital		
Describe What Happened			
<p>Describe what happened. Please be detailed but state only facts.</p> <p>On the afternoon of September 22, 2023, at approximately 12:30 PM, a critical incident occurred involving one of our electrical system workers, Mr. John Turner, while he was performing routine maintenance on an electrical panel at a commercial client's premises.</p> <p>The incident took place at Industrial Avenue, Los Angeles, CA during a scheduled maintenance visit. Mr. Turner was assigned to inspect and troubleshoot an electrical panel supplying power to various machinery in the client's manufacturing facility. While conducting his work, Mr. Turner identified a potential issue with one of the circuit breakers that required immediate attention.</p> <p>Upon opening the electrical panel and attempting to perform a visual inspection, Mr. Turner inadvertently made contact with a live wire due to inadequate labeling and a lack of clear identification of the circuit breaker in question. This resulted in an electrical shock, causing Mr. Turner to sustain injuries.</p>

A photo of the live wire that John Turner was exposed to

Inspect all labels on electrical panels to avoid workers' direct contact with hazardous systems.
