Condition Monitoring Checklist

18 Jul 2025 / Harry Jones

Machine Name Drilling Machine

Model and Year Haas DM-2/ 2016

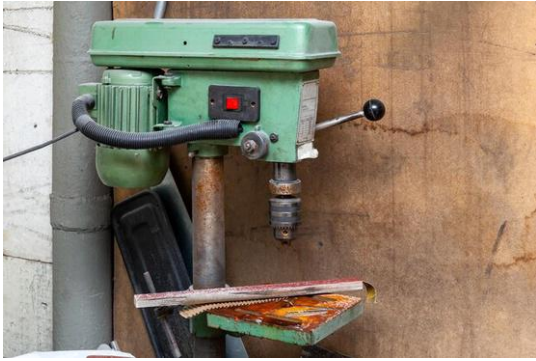
Photo 1

Rusting on the sides

No

Will need maintenance each month

Monthly Check-in

Check if the rusting on the sides gets worse
