ISO 9001:2015 Lessons Learned Log - Industry Vetted

8 Aug 2025 / Michelle Moores

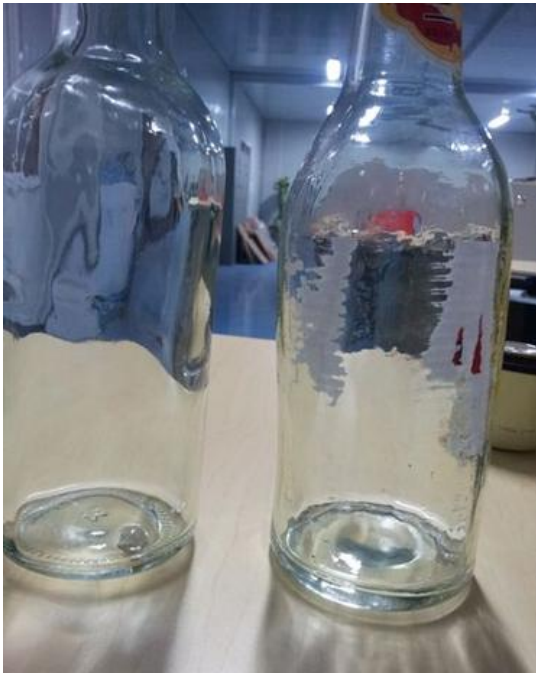
Photo 1

Lessons Learned		
Product/Project		
Product/Project 1		
Product/Project name		Glass Bottles
Product/Project code		N/A
Date		31 Jul 2025 00:00 PST
Project lead		Jason Todd
Team members		Team Member A, Team Member B, Team Member C
Lessons		
Lessons 1		
Category		
	Manufacturing Process	Quality Control & Inspection
Description of issue		
<div>- Manufacturing process was slower than anticipated in the past month, with increased turn around time</div> <div>- Quality of the manufactured product also declined, with more defects identified during final inspections</div> <div>*Photo attached is one of the most recurring defects as seen on the bottle on the right, as opposed to the bottle that meets quality standards on the left.</div> <div>

</div> <div>Photo 1</div>		
Root causes		Flaw in raw materials
Corrective actions		Change suppliers for raw materials and conduct checks of the manufacturing machines
Impact

Quality	Efficiency	Cost
Preventive actions		Conduct regular maintenance and inspection of raw materials and machine works
