General Drywall Inspection Checklist

Vision Builders / Alex Craig / 31 May 2023

| Jobsite / Address | 314 Shorecrest Ln, Linden, PA 17744, USA (41.2042594, -77.19513119999999) | | | | |

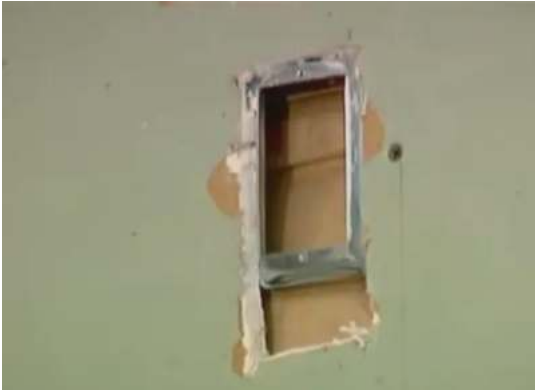
Photo 1

Electrical outlet maximum setback is 1/4" from drywall face and no side gaps more than 1/8" to electrical outlet

No

Apply joint compunction

Use strait-flex outlet patch with joint compound

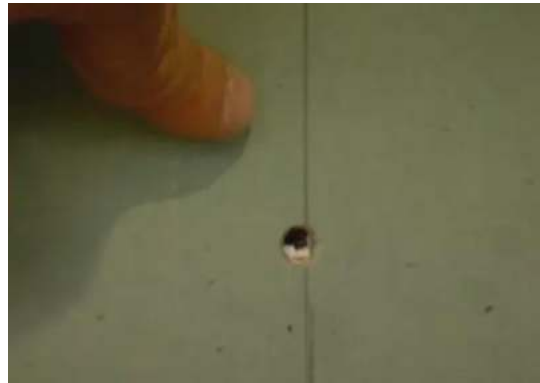
Photo 2

All screws are gypsum board type "W" or "S" unless otherwise noted and long enough to penetrate a minimum of 5/8" into wood and 3/8" into steel

No

Screws used for drywall are all correct. However, some screws were driven too far and broke some surfaces of the paper face of the wallboard.

Drive new screws

Just drive another screw near the failed one
