Indoor Air Quality Assessment Checklist

Score	7 / 9 (77.78%)	Flagged items	3	Actions	2
Site/Facility/Building Name	Horizon Heights Office Complex				
Location	Brooklyn, NY, USA (40.6781784, -73.9441579)				
Conducted on	18.08.2023 12:30 PST				
Assessor/Inspector Name	Cillian Johnson

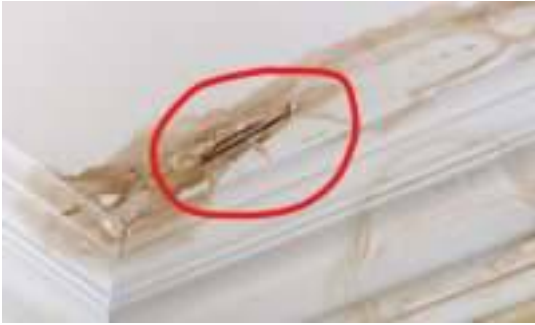
Photo 1

The interior ceiling on the 2nd floor was damaged by a leaking pipe due to substandard plumbing.

Repair ceiling on 2nd floor.

Two corrective actions are needed to be resolved until next Friday, August 25. Both issues were found on the 2nd floor, one in the ceiling and one in the bathroom. Both are pollutants, so immediate resolution is recommended.

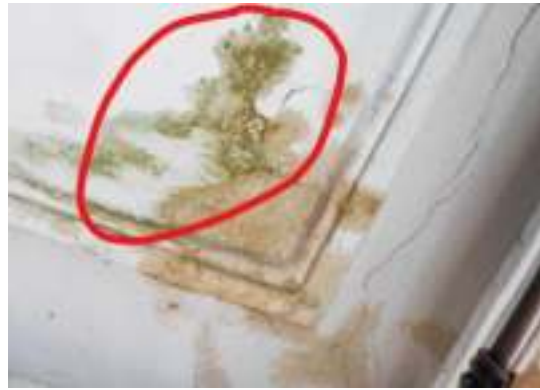
Photo 2

Evaluate presence of mold or moisture issues in bathrooms, kitchens, and other areas.

Address mold growth in the 3rd bathroom cubicle on the 2nd floor.
