HAZOP Template

Zoraya Chemical Mixing Plant / Serrah Engel / 26
Apr 2023

Hazard & Operability Analysis (HAZOP)

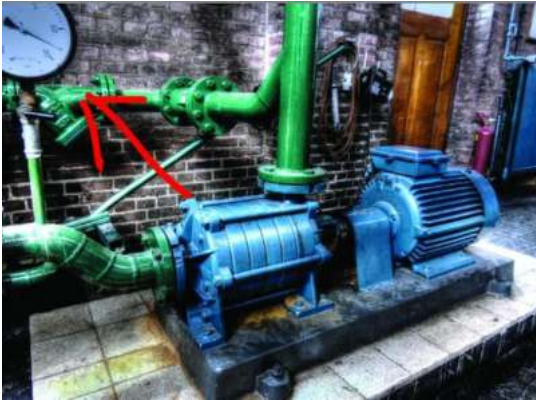
Photo 1

No RO water flow

Centrifugal pump loses priming or valve closed totally

Resulting in highly concentrated solution

Proper monitoring of the centrifugal pump (hydraulic pressure)

Hydraulic pressure gauge should be reviewed and maintained on a regular basis.

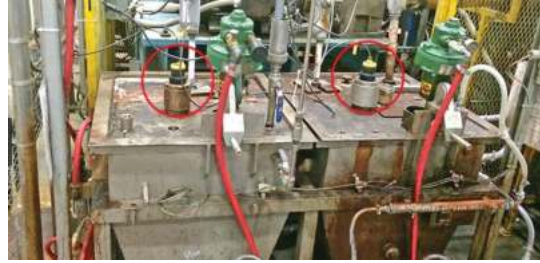
Photo 2

More RO water flow than intended

Water passes through the valve even if it's closed

Overflow of the batch mixer

Person assigned to monitor batch mixer content

A level indicator needs to be installed for an automatic, accurate reading of the levels.
