# Ventilation Checklist

Safetyden Building Inc. / A-13345 / 22 Jun 2023

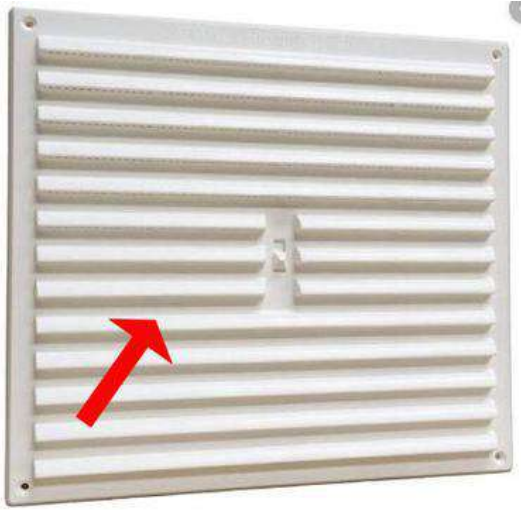
Photo 1

There is a closed vent exhaust at bay 2

- Keep vent open at bay 2
  - Check installation of vent covers at bay 3
  - Fix the disturbing sound detected upon start up of ventilation systems
-

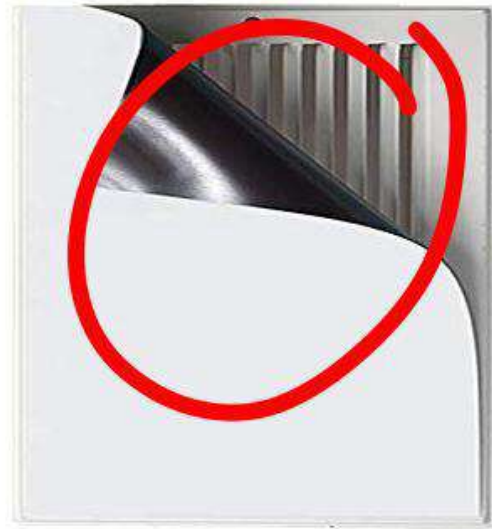
Photo 2

Magnetic exhaust vent cover for bay 3 is not installed properly

Check and fix ventilation cover
